Moisture-Induced Delamination Video of an Oxidized Thermal Barrier Coating

James L. Smialek, Dongming Zhu, and Michael D. Cuy
NASA Glenn Research Center, Cleveland, OH 44135

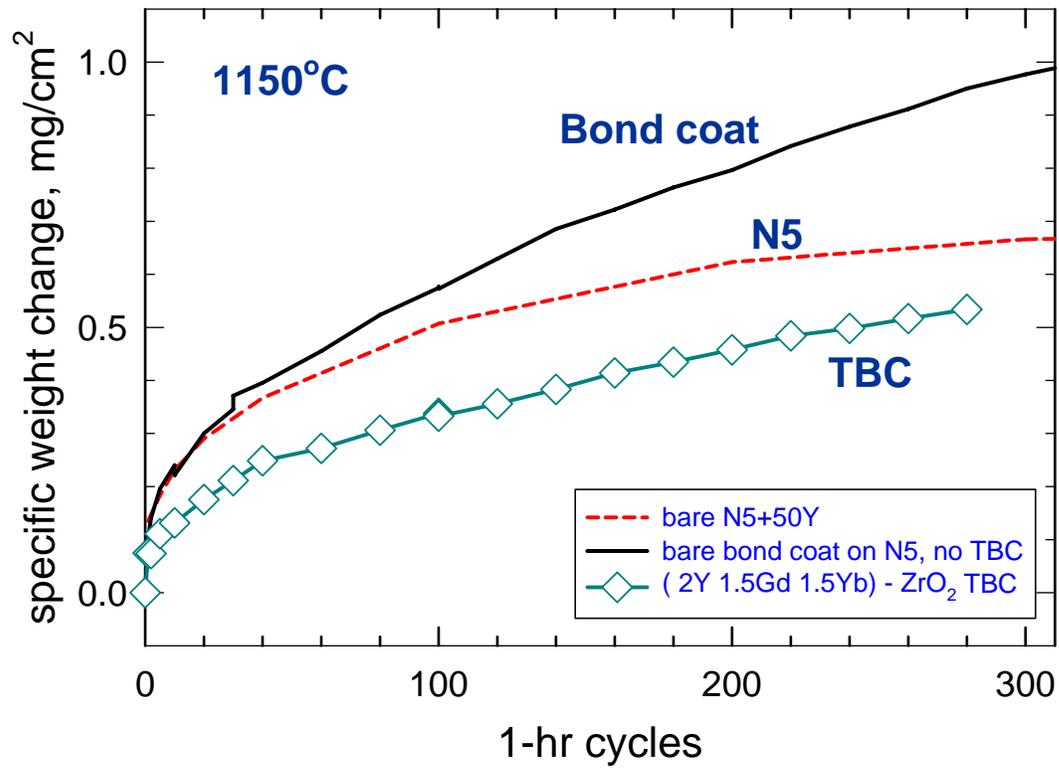
The weight change of a bare aluminized sample (with no TBC) is shown as the solid line in figure 1, reaching about 1 mg/cm^2 after 300 hr. By comparison, the subject TBC sample (diamonds) gained less weight, about 0.5 mg/cm^2 . This suggests that the TBC covering one side of the sample reduced the overall weight gain substantially. Using the conventional conversion resulting from the 3.99 gm/cm^3 density of $\alpha\text{-Al}_2\text{O}_3$, this translates to an $\alpha\text{-Al}_2\text{O}_3$ scale of about 5.3 and $2.7\text{ }\mu\text{m}$ for these two samples, respectively. The TBC weight gain data is seen to behave quite regularly, generally showing no perturbations that might result from random TBC micro-spallation, except at 100 hr. Finally, data from an uncoated Rene'N5 + 50 ppmw Y sample is seen to lie between both curves [11].

Figure 1. Specific weight change of bare, Pt-aluminide-coated, and TBC-coated Rene'N5 disc samples, oxidized at 1150°C using 1-hr cycles.
